## AN ASSESSMENT OF WEATHERING STEEL BRIDGES IN WEST VIRGINIA

### ABSTRACT

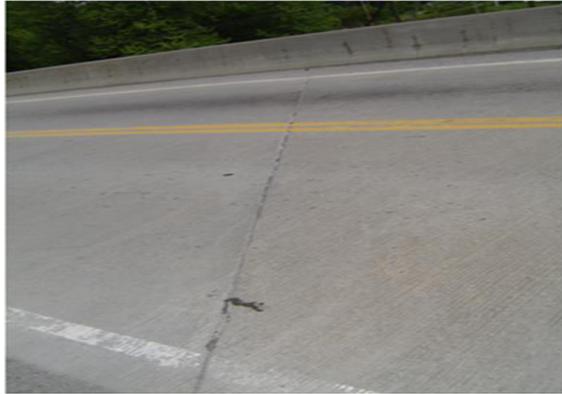
(a) Deck joint

Fig. 1. Corrosion caused by open deck joint

Construction joints in concrete decks should be grouted. These joints should be carefully inspected during biennial inspections to monitor water penetrability. In many newer bridges, a construction joint located approximately 10 ft from the abutments was observed; consideration should be given to revising design practices to eliminate this joint.

Decks should be periodically inspected for cracks and open joints as well as signs of moisture penetrating through the deck. Any of these occurrences should be repaired. Caulked joints encountered during the bridge inspections appear to be adequate in preventing future corrosion.

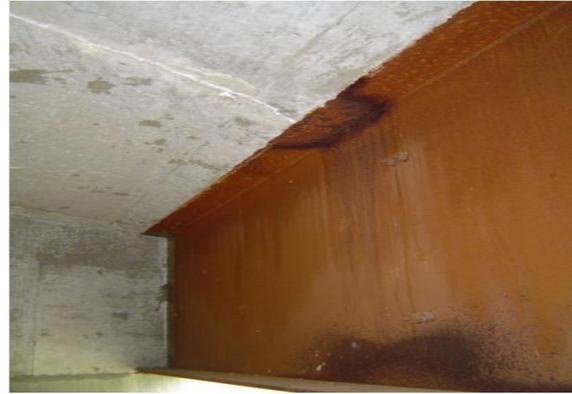
Bridges with reinforced concrete decks exhibit the fewest corrosion problems. This is attributed to the fact that the concrete decks are generally a continuous surface, thus preventing water from penetrating the deck and reaching the steel elements below. However, when cracks or inadequately sealed construction joints are present in the surface of the deck, corrosion problems beneath these cracks and joints frequently exist. One such situation is shown below in Fig. 1.

(b) Corrosion beneath joint

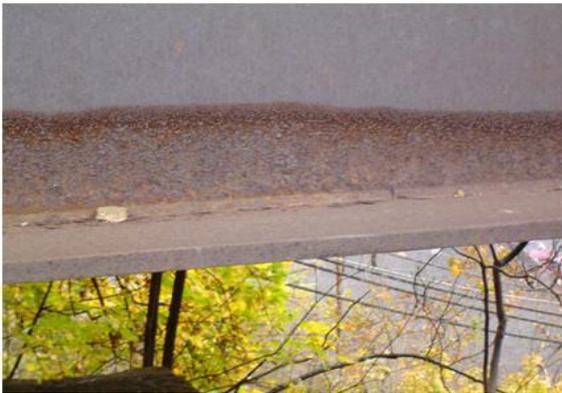
It is also observed that concrete decks with relatively wide overhangs exhibit significantly less corrosion on the exterior girders. Corrosion on the bottom flanges and the bottom of webs of exterior girders is common in cases where the depth of the girder is greater than the width of the overhang. This is caused by the lack of shelter to the exterior girder. The horizontal surface of the bottom flange then allows water to accumulate and capillary action draws this moisture up the web. An example of this situation is shown in Fig. 2a. This water also flows along the bottom surface of the bottom flange leading to corrosion as depicted in Fig. 2b.

(a) Corrosion of bottom flange and web

Fig. 2. Corrosion due to narrow overhang

The overhang width should be extended as wide as feasible to provide additional shelter to exterior girders.

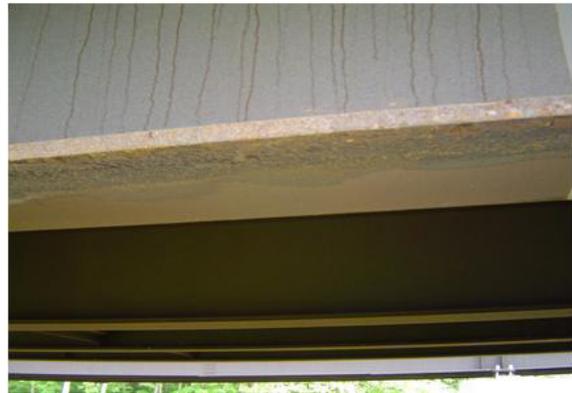
(b) Corrosion of bottom flange

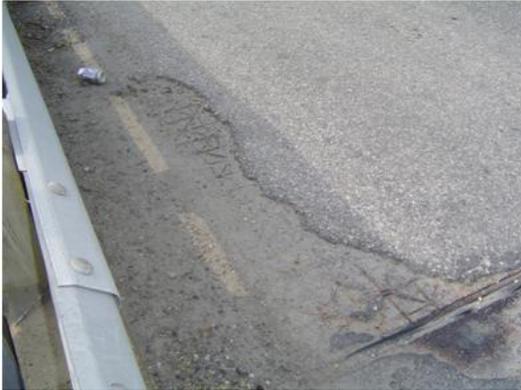
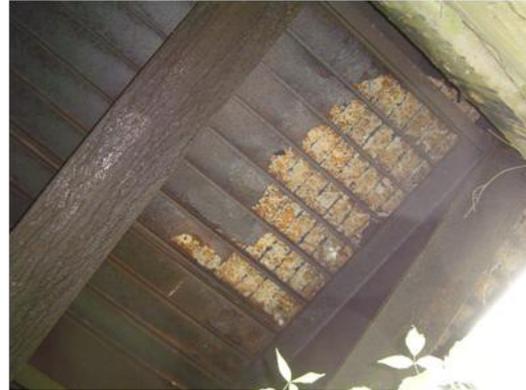
Fig. 3. Concrete-filled metal grid deck

Several bridges were inspected where the bridge deck was comprised of concrete-filled metal grid decks. All of these decks had been in service for several years and all were leading to corrosion problems on the weathering steel members. Typical photographs of this type of bridge deck are shown in Fig. 3, where it can be seen that this deck type consists of three components: a geometric steel grid, a stiffened bottom plate, and the concrete in-fill. It is evident that water is able to pass through the filled grid deck, which eventually deteriorates the underlying stiffened plate, and allows run-off to flow over the weathering steel members. Thus the weathering steel is frequently exposed to moist conditions and excessive corrosion results.

(a) Grid deck from above

(b) Grid deck from below

A deck consisting of a continuous, solid surface should be provided. Reinforced concrete decks with or without stay-in-place metal deck forms are recommended. Conversely, the use of timber decks and metal grid decks (filled with concrete or unfilled) is highly discouraged as these decks do not prevent water from reaching the girders and in many cases act to trap water on the top flange of the girders, exacerbating the situation.

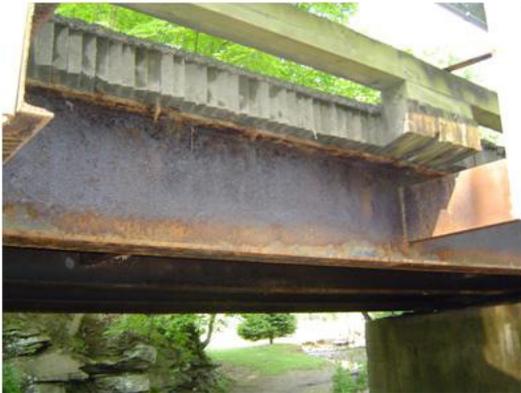
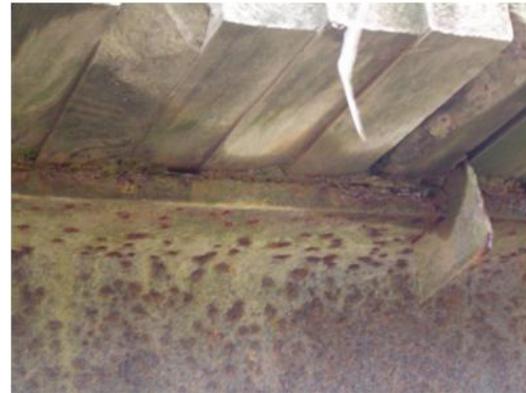
Fig. 4. Typical corrosion on bridges with timber decks

The inspected bridges with timber decks had serious corrosion issues. Similar to the problem cited above with concrete-filled metal grid decks, water easily penetrates between each joint between timbers, providing little shelter to the weathering steel. Furthermore, the timber deck also retains moisture, which worsens the already severe corrosion of the top flange. Figure 4 shows corrosion typical of a weathering steel bridge with a timber deck. It should be noted that many of these bridges have been painted and the paint systems are also failing on these bridges.

(a) General view

(b) Pack rust on top flange

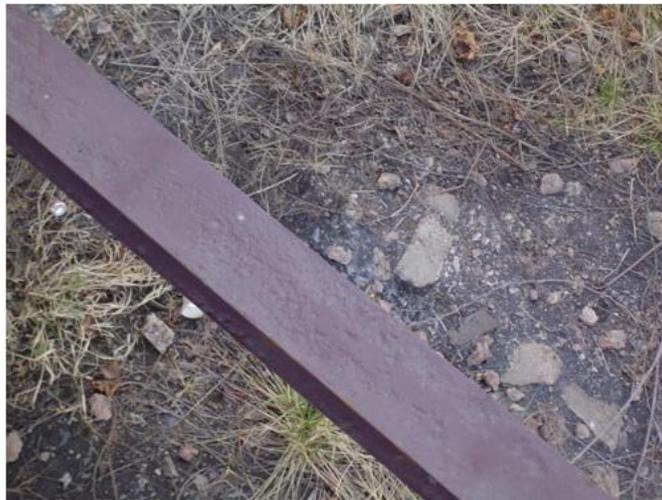
The negative aspect of these bridges is that they contain numerous members that are completely exposed to the elements. Especially problematic are: horizontal members where ponding of water may occur; inclined members, particularly at bearings, where members are oriented in such a way as to allow water to collect in places where there is no mechanism for drainage; and open cross-sections particularly in combination with connections that allow for moisture to enter the section. Examples of each of these three conditions are shown in Figs. 5-6, respectively. Fig. 5 shows a heavily pitted horizontal member of a steel deck truss. The excessive corrosion in the interior of an open truss member is shown in Fig. 6; here the substantial corrosion of the bottom bolts should also be noted.

Fig. 5. Horizontal member of deck truss

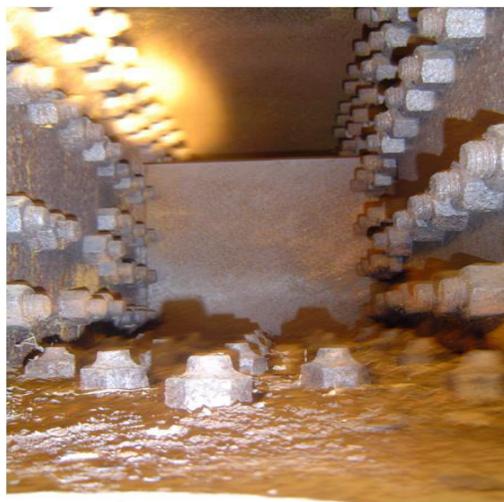
Fig. 6. Corrosion inside open truss member

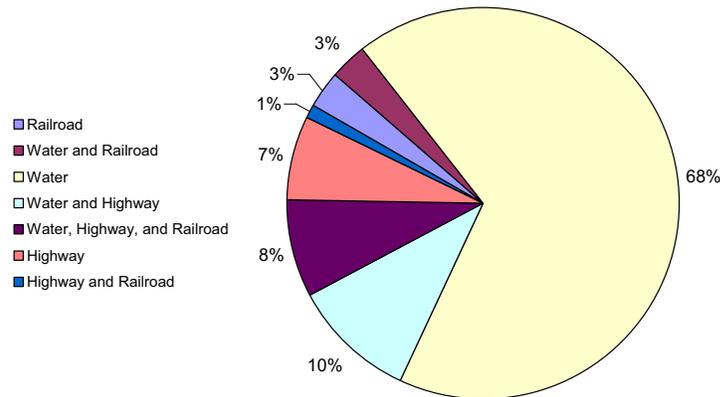
The inspected bridges serve to cross bodies of water, highways, railroads, or some combination of these three. Figure 7 describes the weathering steel population with respect to crossing type, where it is shown that 89% of the bridges cross water, 26% cross highways, and 15% cross railroads. The influence of crossing type on corrosion performance is discussed below.

Fig. 7. Categorization of WV weathering steel bridges
