QUALITY BRIDGE & FAB, INC.

PennDOT Messerall Bridge
Truss Restoration / Relocation

Project Information

Project Scope

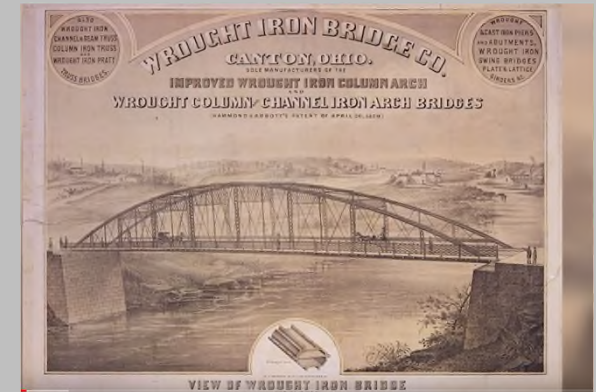
- Built in 1876 by Wrought Iron Bridge Company (146 Year Old Bridge)
- Bowstring Truss
- 103' Span / 17'-6" Truss Width
- Installed in Oil Creek Township, PA
- Owned / Maintained by Crawford County, PA until bridge closed in 1987

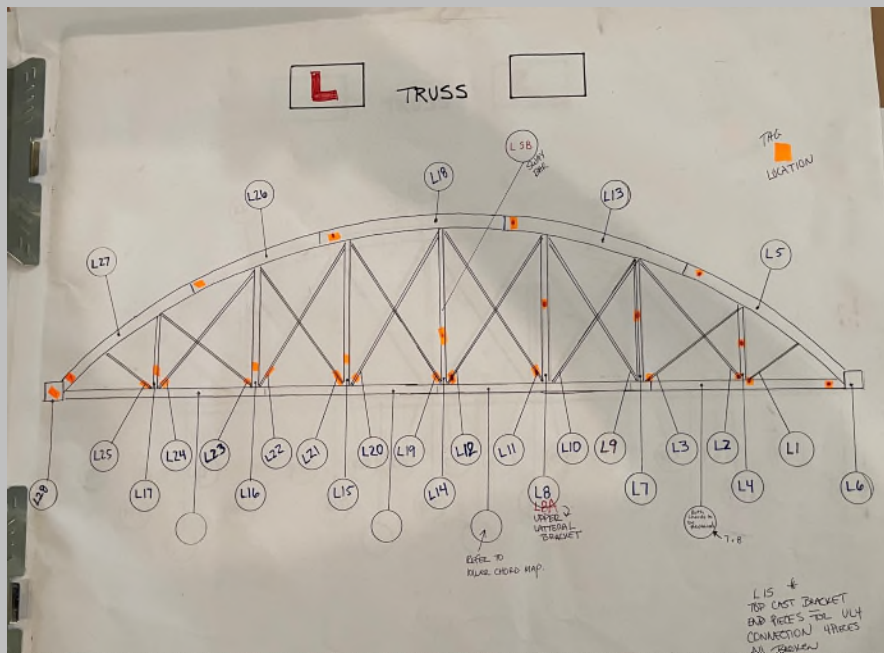
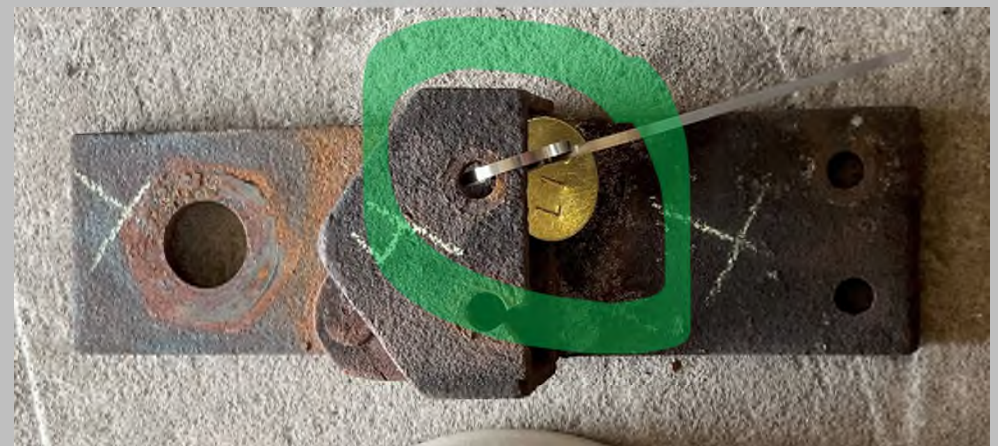
Removal / Restoration

- Bridge Removed from Oil Creek Township
Disassembled on site by Blacksmith / Contractor
- Tagging and Layout of each part

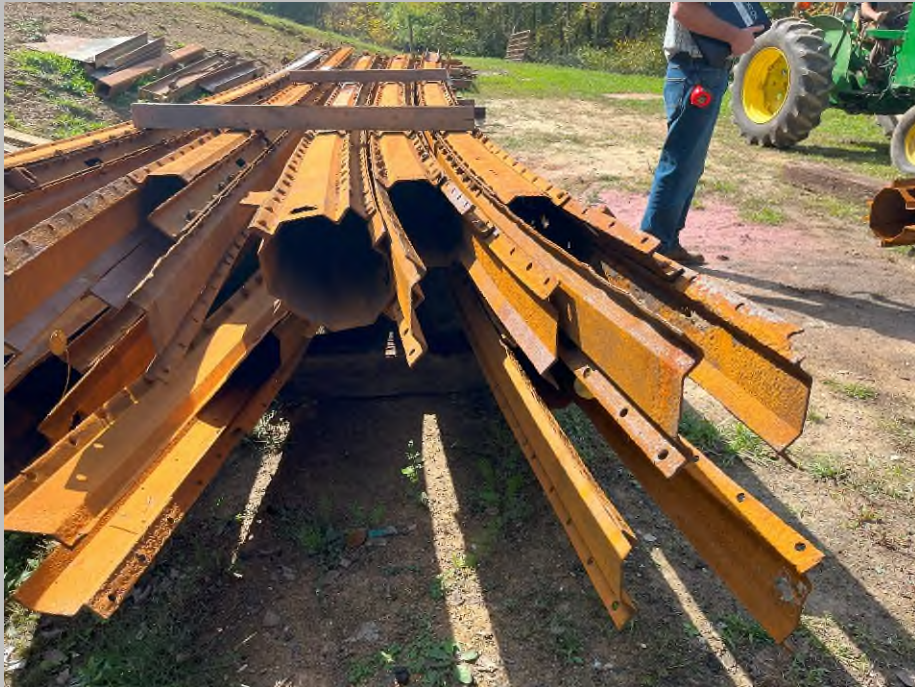
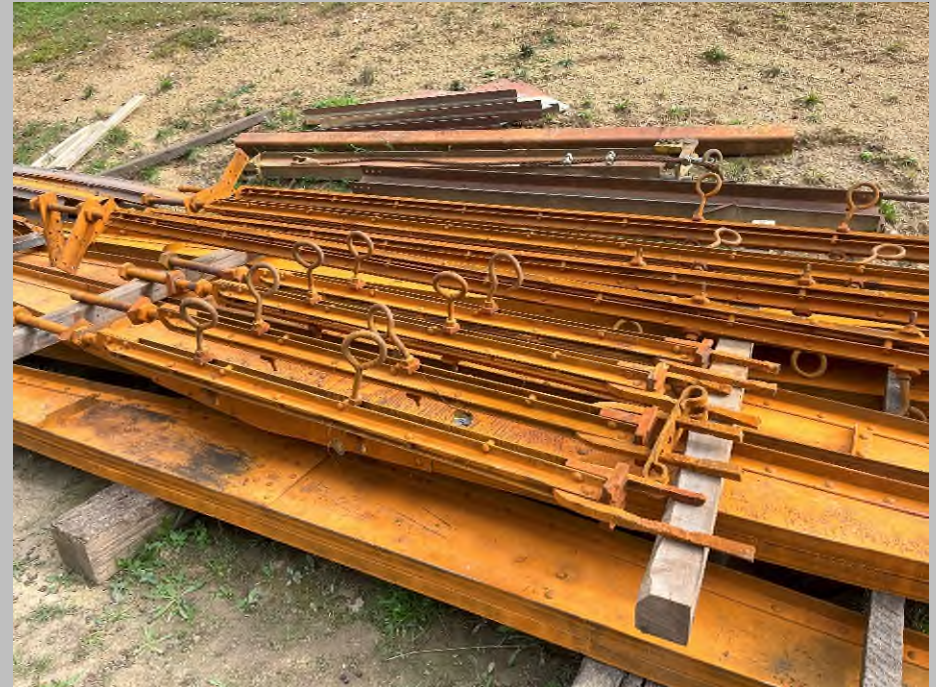
Removal / Restoration

- Entire Structure was sandblasted
- Shipped to Lockhart Ironworks (Logan, OH)

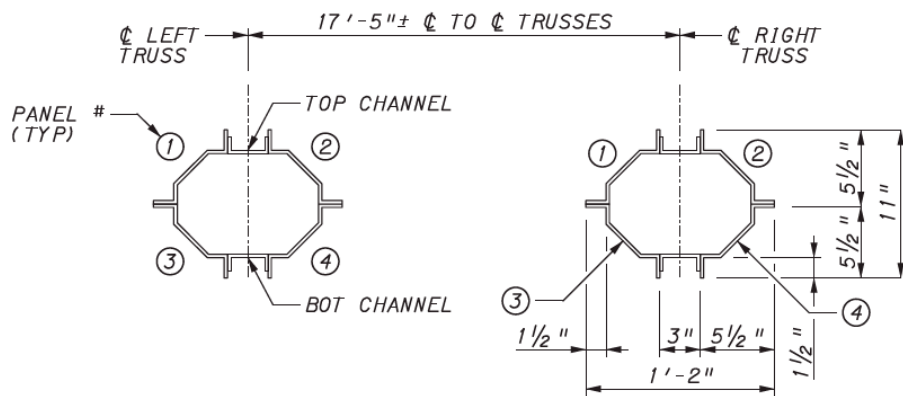
Box Section Components

NOTES: ALL PANELS MADE OF BENT 1/4" THICK PLATE.
 ALL DIMSNEIONS ±.
 FIELD VERIFY ALL DIMENSIONS PRIOR TO SHOP DRAWING
 SUBMISSION.

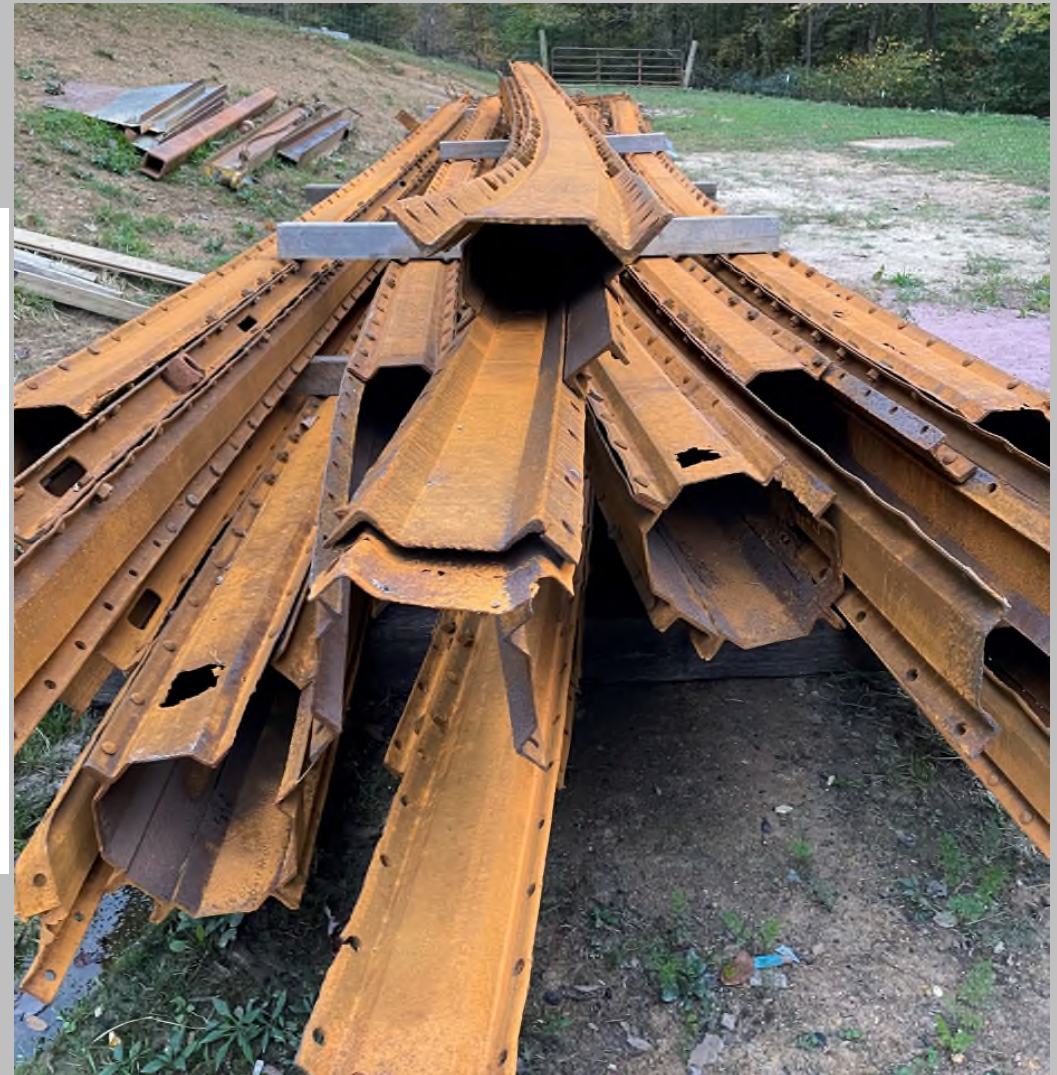
TRUSS TOP CHORD - TYPICAL SECTION

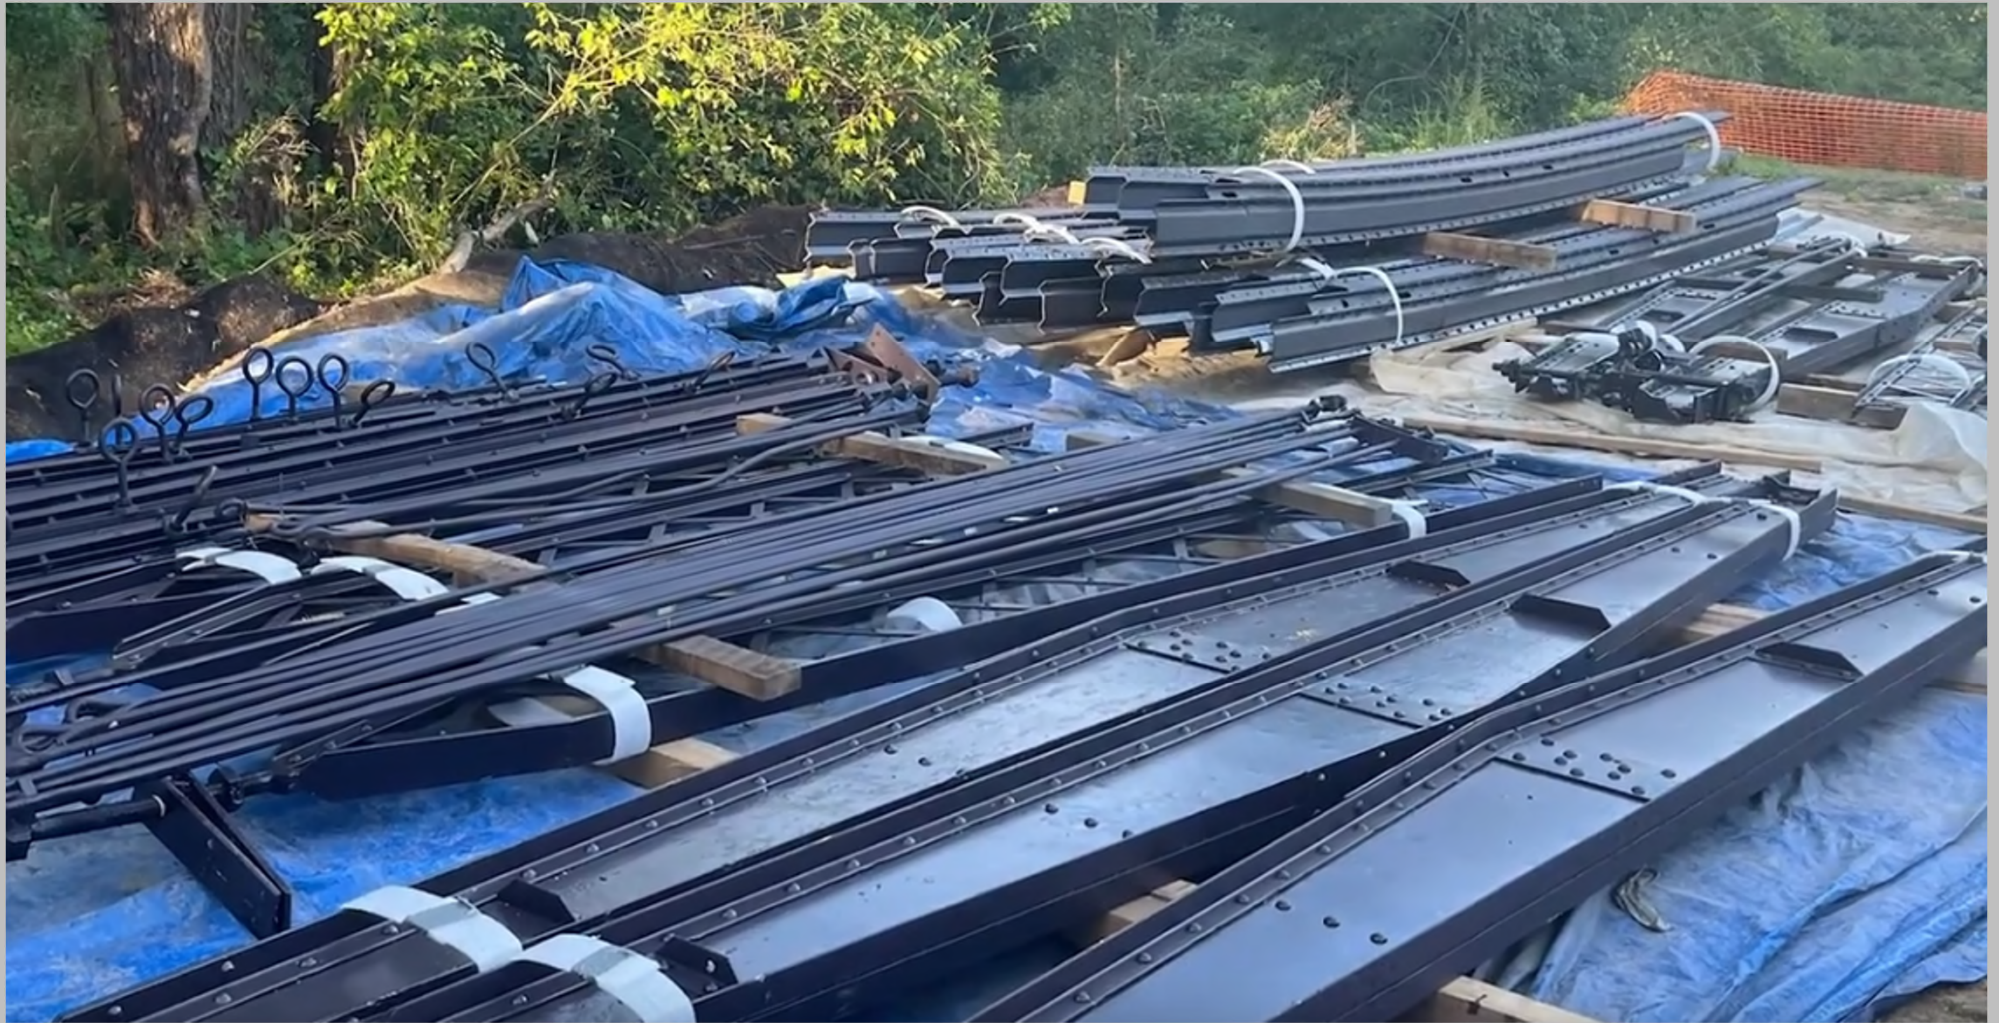
Site Assembly / Installation

- Shop Painted New and Existing Components
- All Shipped to Site for re-assembly
- Approximately 6,000 Rivets on Bridge
 - 2,500 +/- Replaced during Restoration
 - 150 +/- Field Installed
- Approximately 75% of Original Components Salvaged
